815-835 Yan Yean Road, Doreen

Development Plan

Prepared by Head & Humphreys for Corvac P/L

31th March 2017

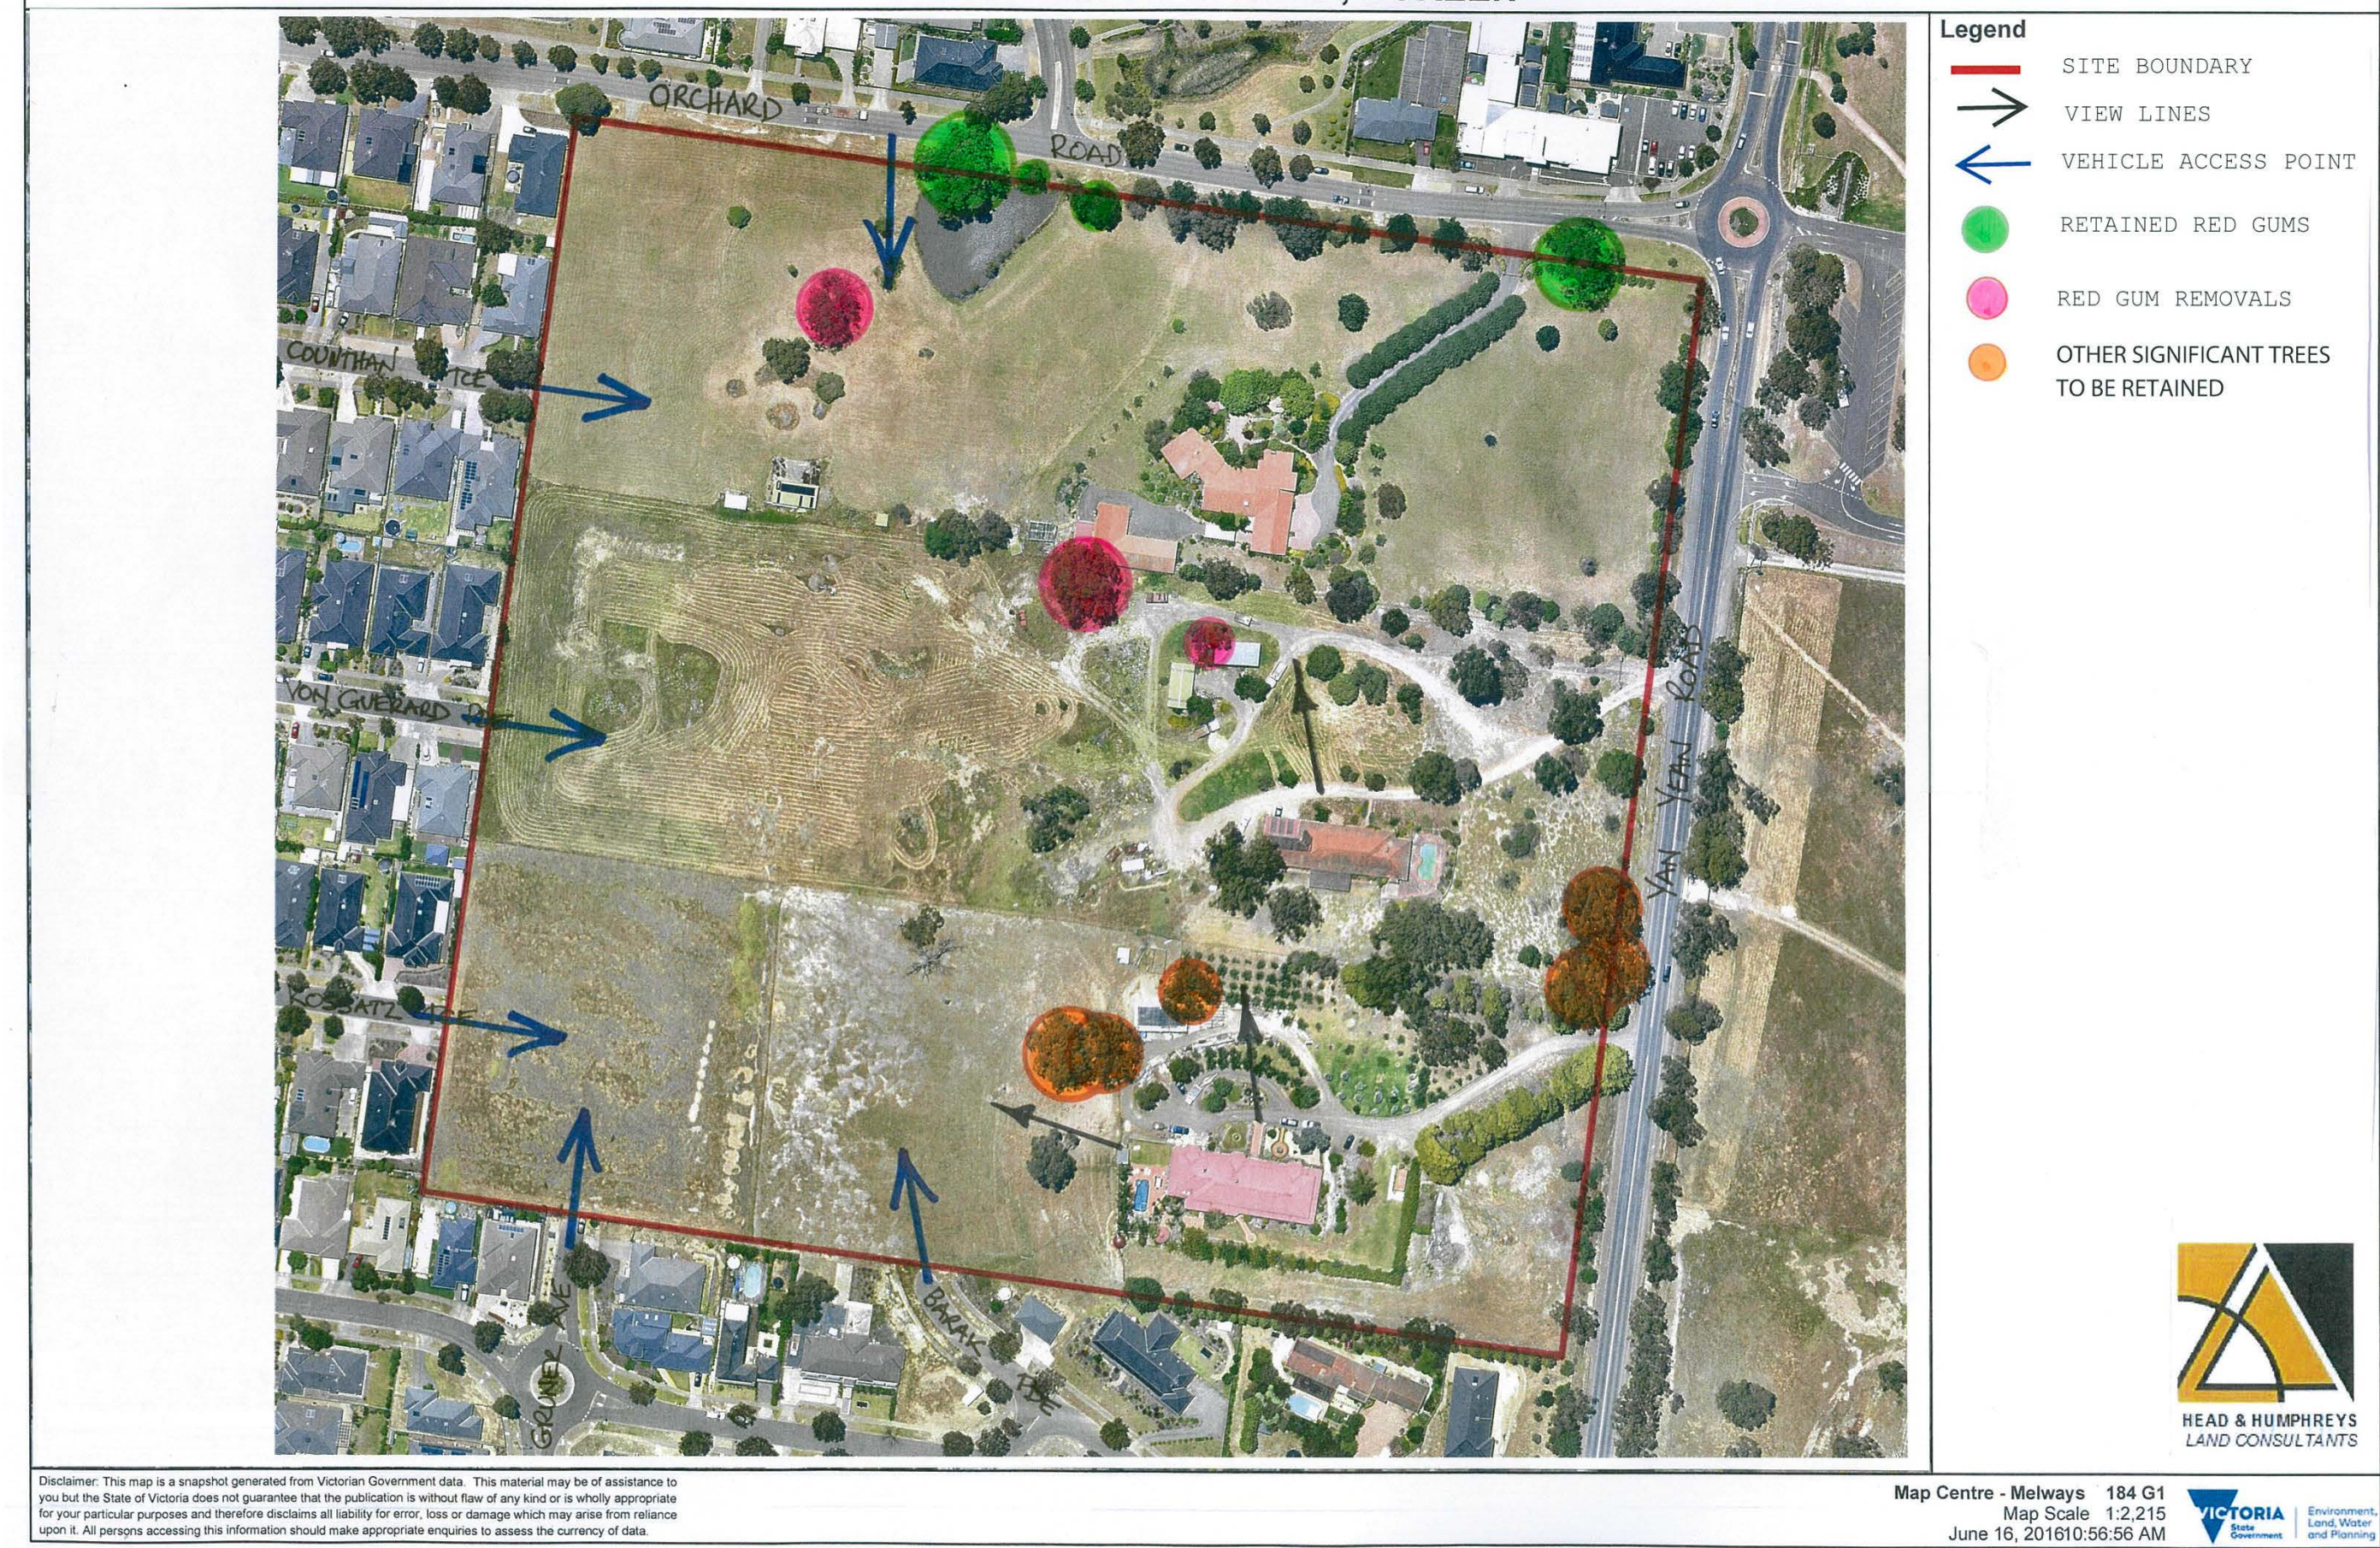
Figure 3 – SITE ANALYSIS PLAN

Figure 2 – Site Analysis Plan illustrates the existing land uses and land form conditions and significant trees on site.

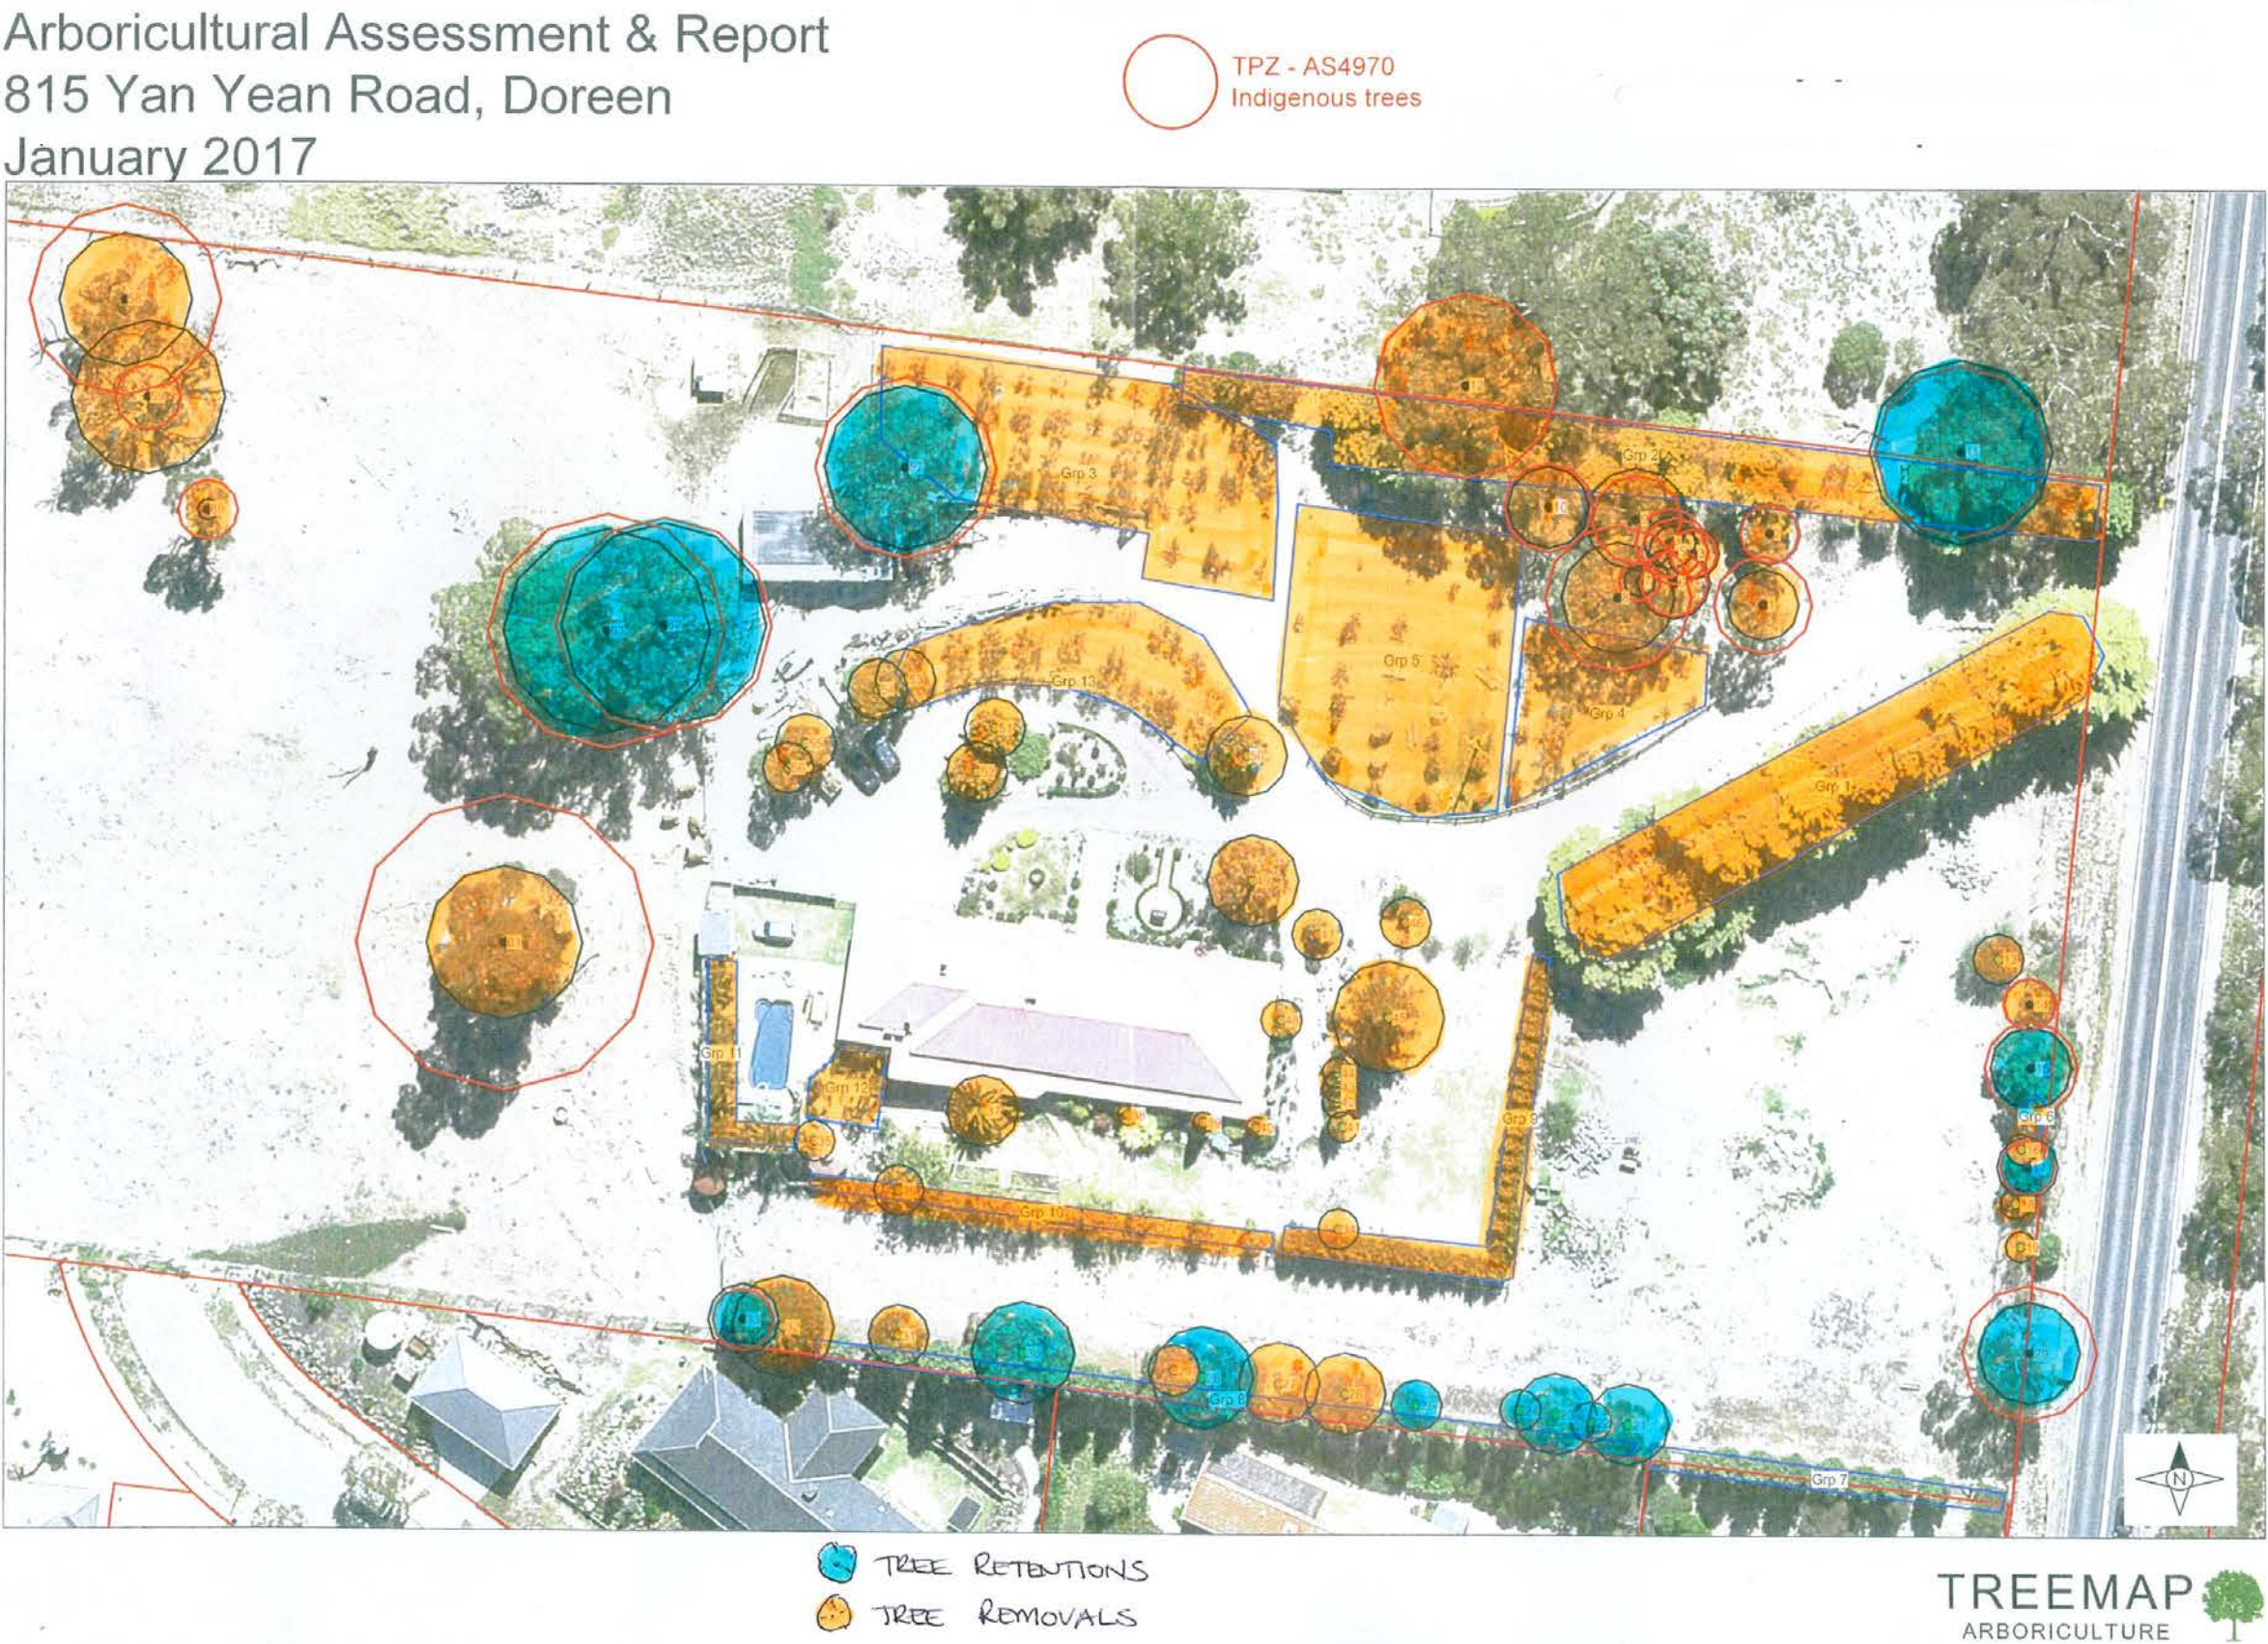
Figure 8 – TREE PLAN 815 YAN YEAN ROAD, DOREEN

Arboricultural Assessment & Report
815 Yan Yean Road, Doreen
January 2017

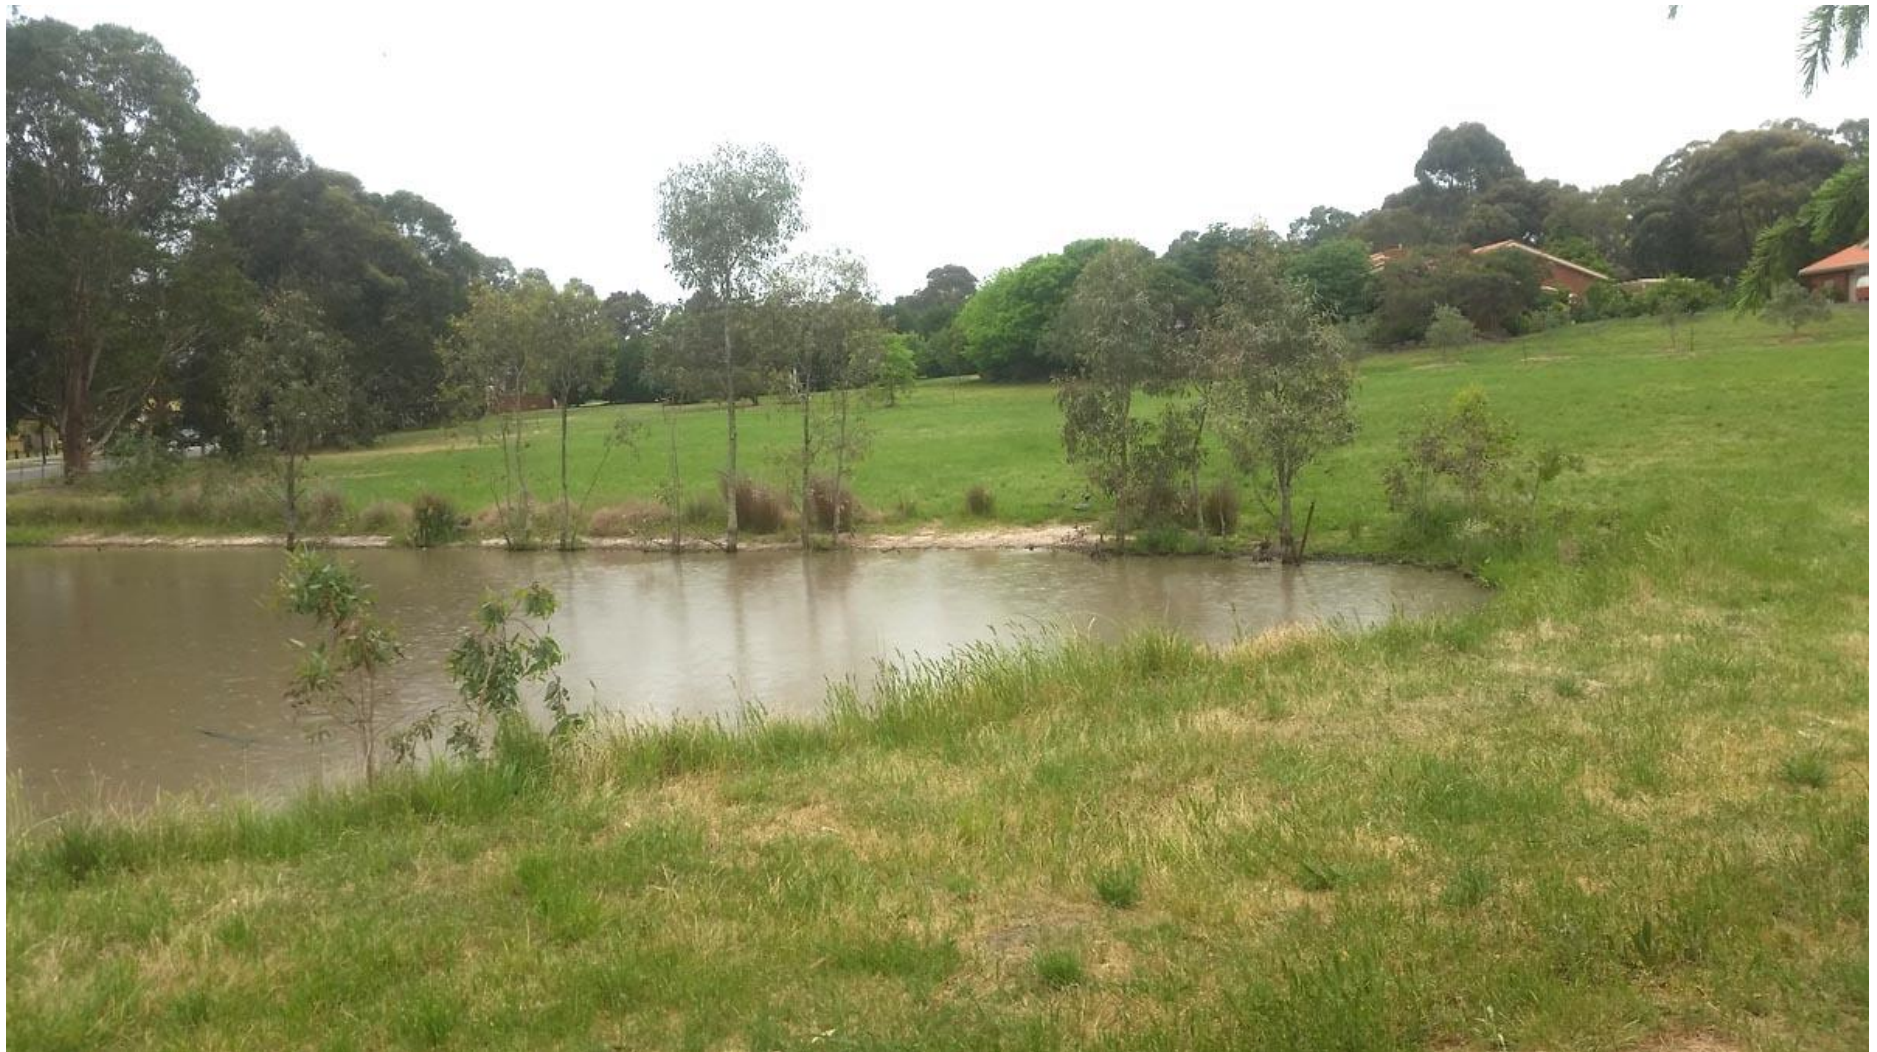
Figure Three: Juvenile Red Gums (*Eucalyptus camaldulensis*) to be removed.

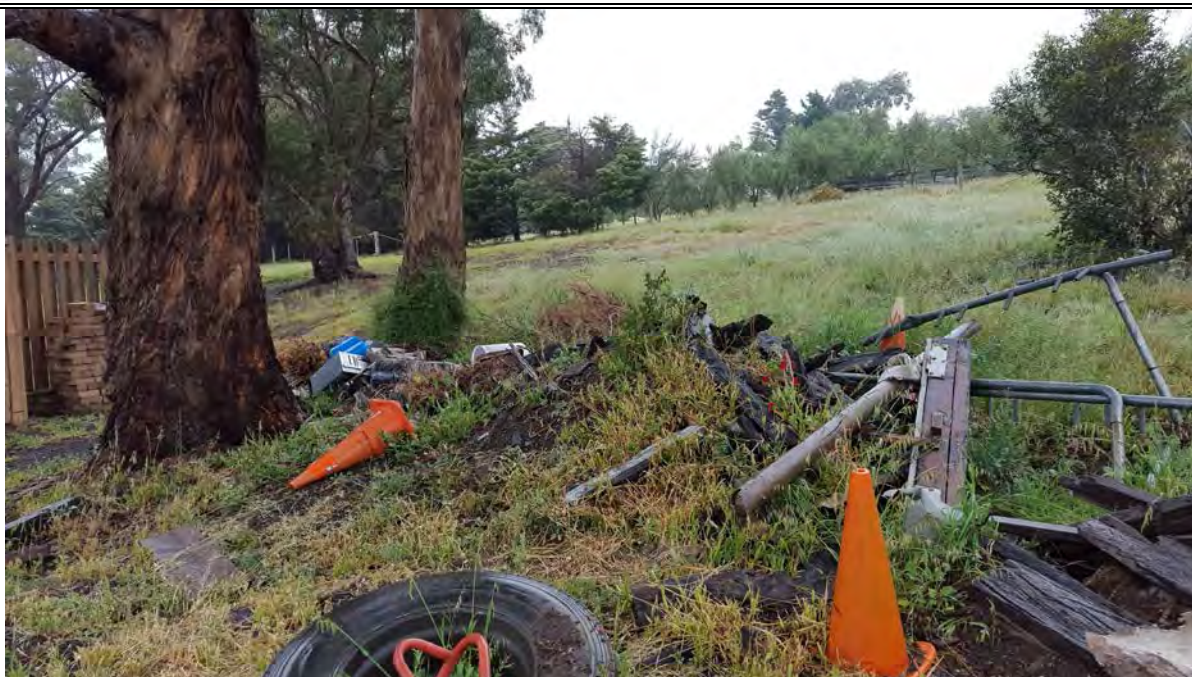
Photograph 1. Waste Storage Area: Area 4 on Figure 2. Hand auger HA1 located in this area.

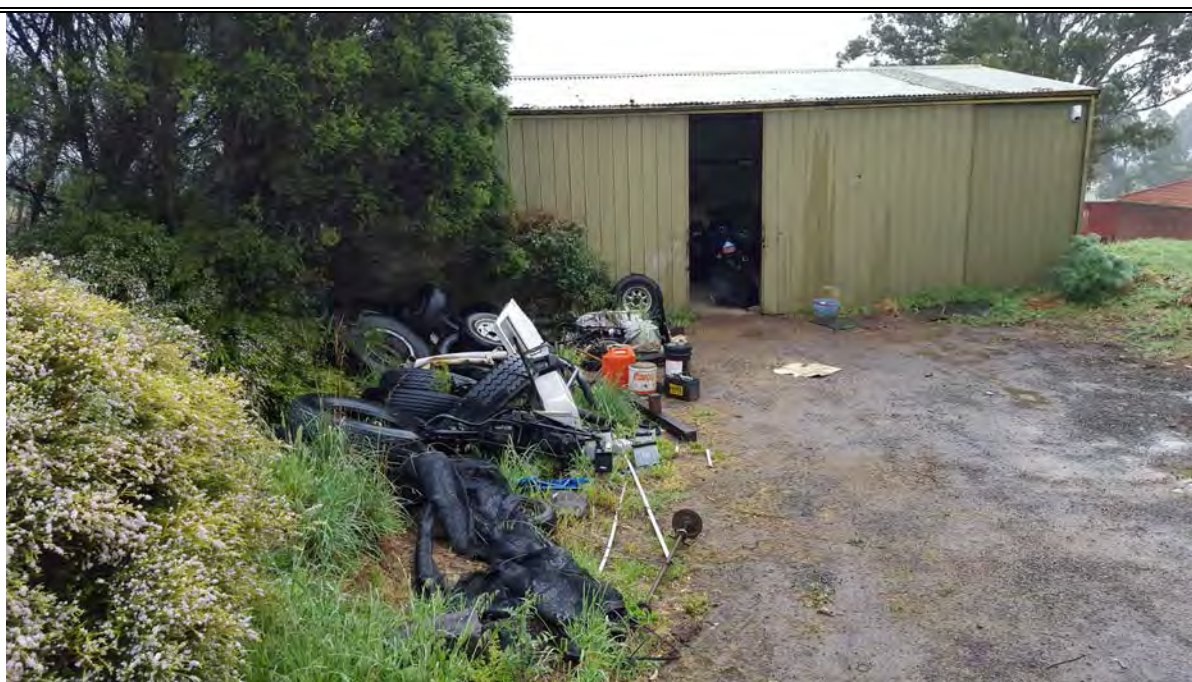
Photograph 2. Maintenance Area and Waste Storage: Photo taken from area 2 on Figure 2. Hand Auger HA3 taken from area next to oil containers and lead-acid batteries.

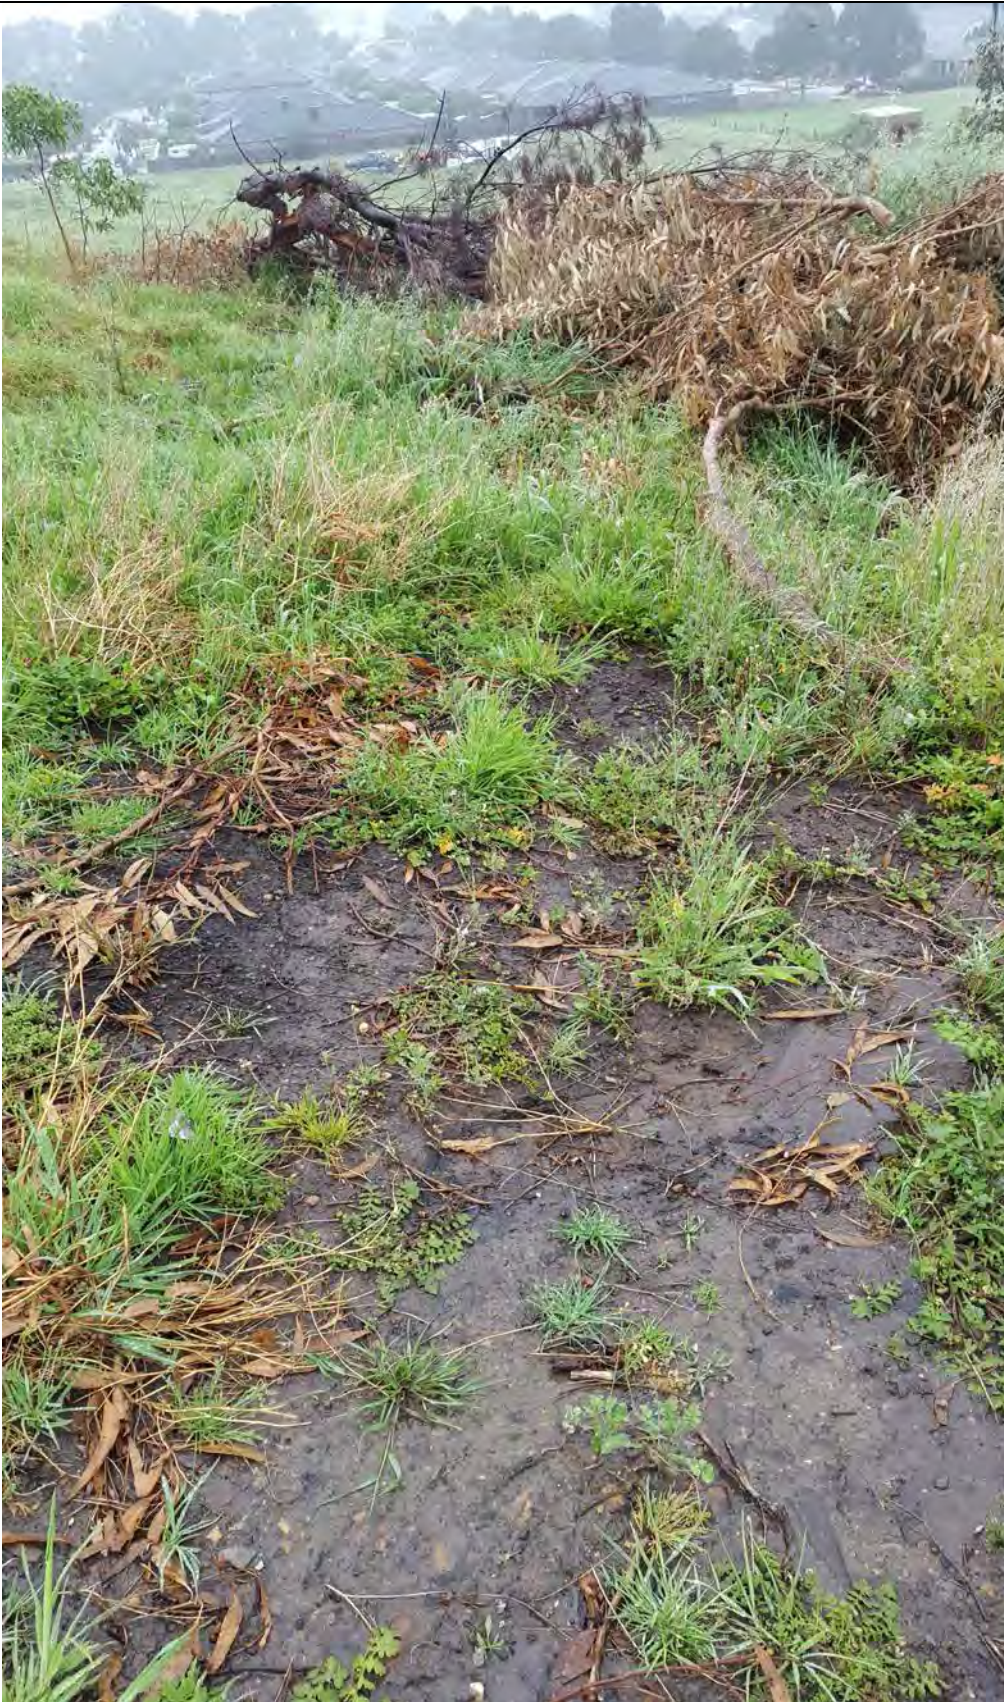
Photograph 3. Burn Area: Area 3 on Figure 2. Sample taken from HA2.

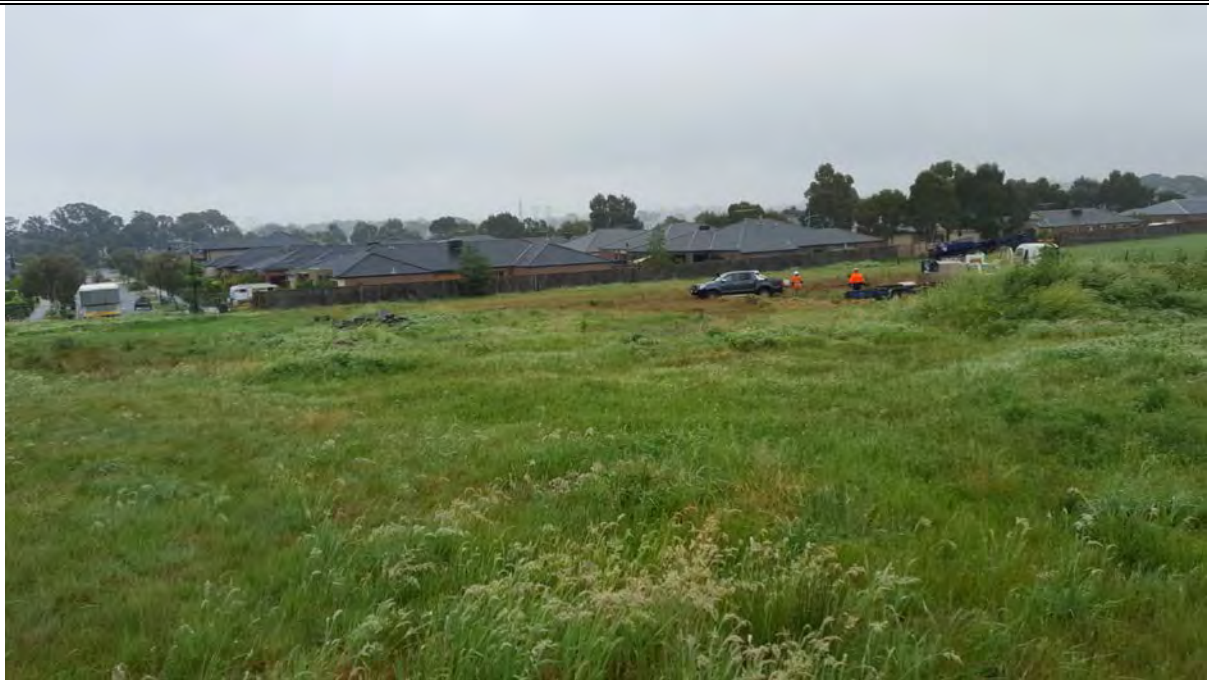
Photograph 4. Old Dam Site: Photo looks south towards old dam site, where BH1 is being drilled.

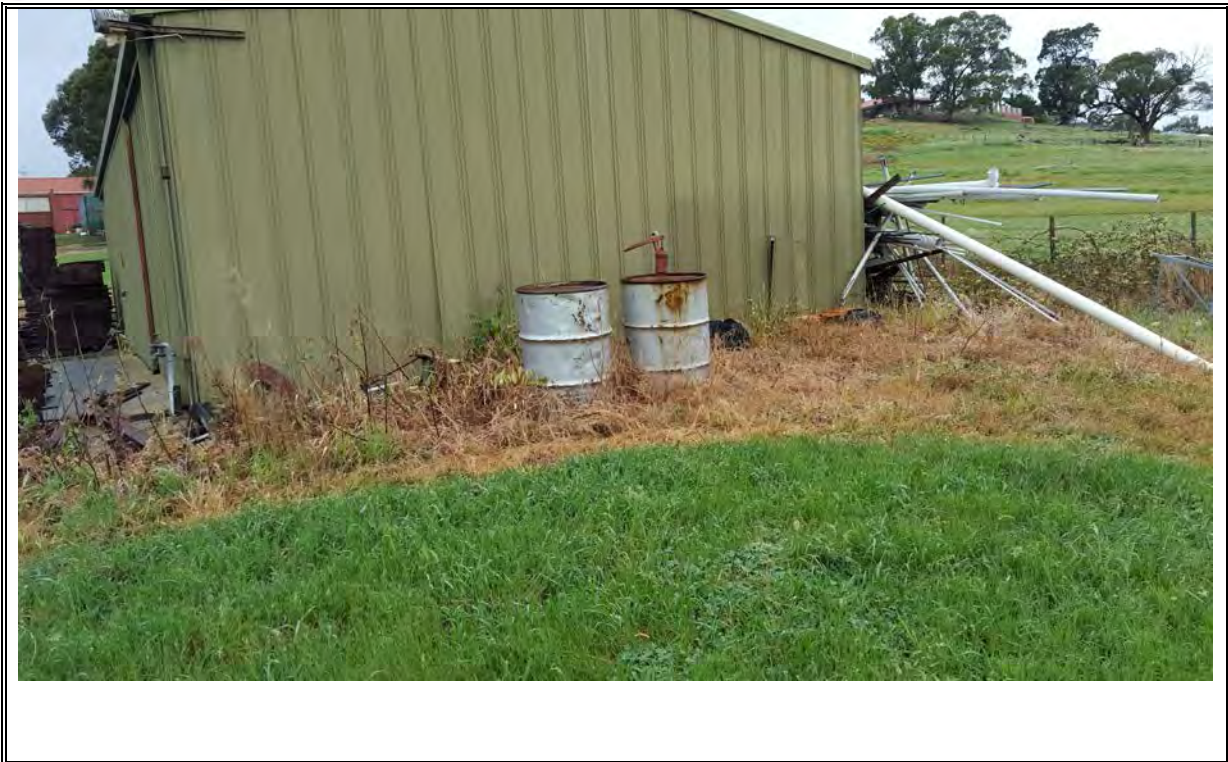
Photograph 6. Drum Storage: Area 8 on Figure 2. 4 x 205 L drums stored in this area. No evidence of leaks or spills.

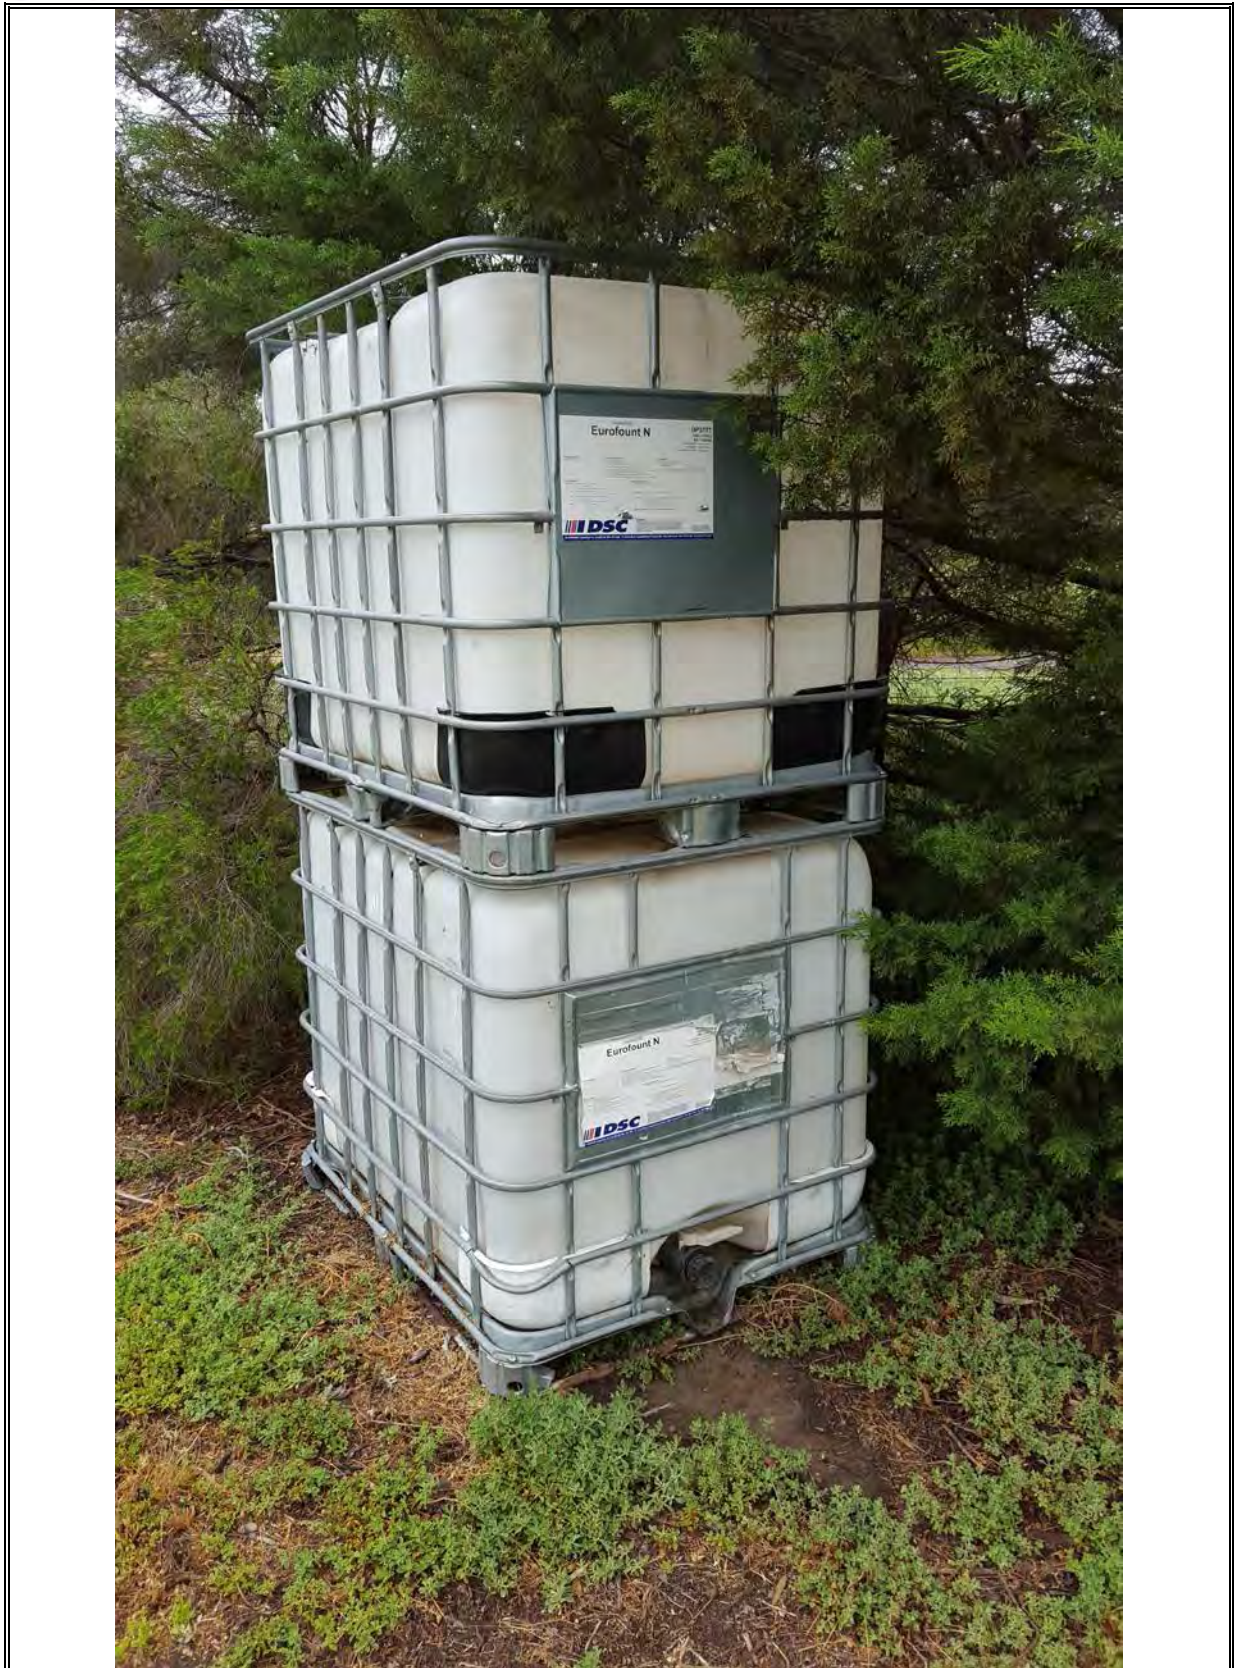
Photograph 7. Chemical Storage: Area 9 on Figure 2. 2 x empty IBCs which contained Eurofount, a biocide and solvent.
