Statement of Significance: Bindt's Farm

Address: 100 Bindts Road, Wollert	PS ref no: HO161
Heritage Place: Bindt's Farm	PS map ref no: 17

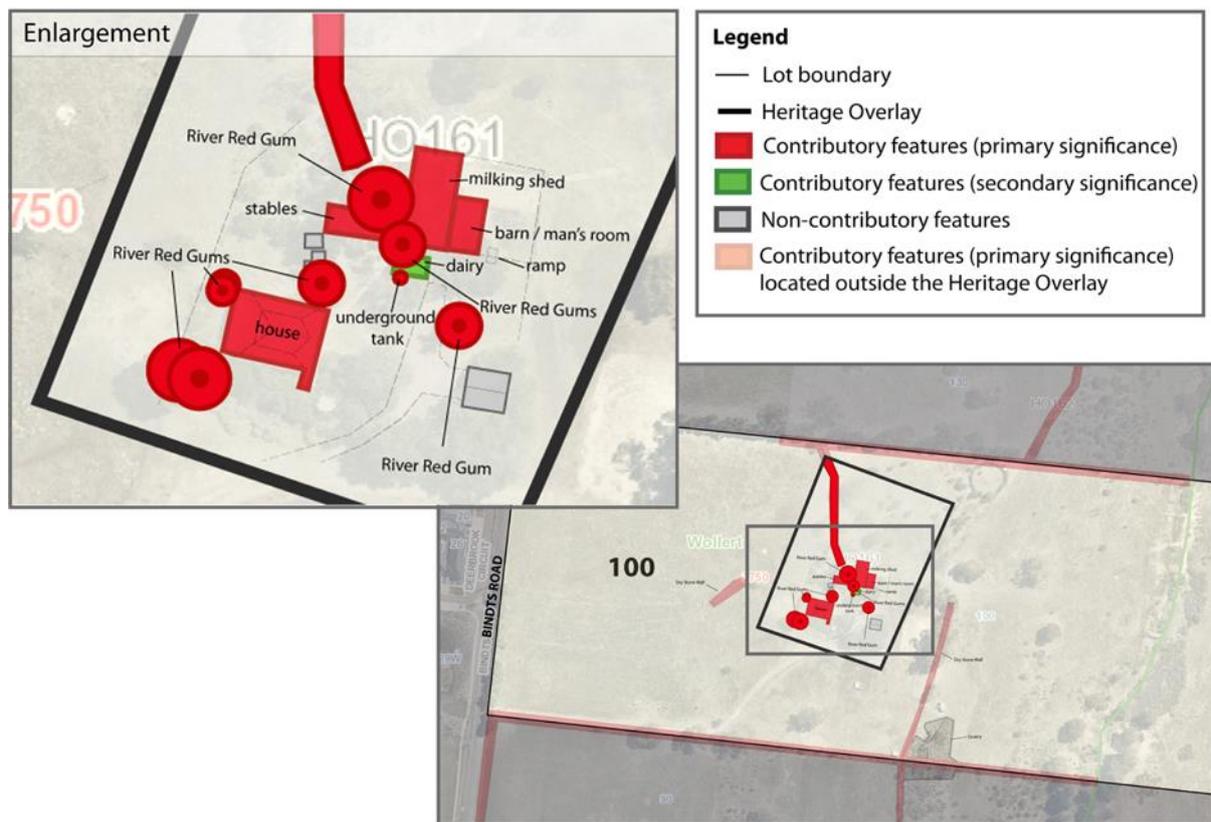
Figure 1. Contributory features of primary and secondary significance, and Non-contributory features and Heritage Overlay boundary.

As shown on Figure 1 contributory features of primary significance are:

- Basalt house and associated stone paving,
- Stone stable, milking shed, stone paved yard and underground tank or well to south of it,
- Dry stone walls, including remnant of garden wall west of house,
- Quarry beside Darebin Creek, and
- The traditional landscape setting of flat grasslands with stony rises beside the Darebin Creek valley and remnant River Red Gums that links the three historic farms along the east side of Bindts Road.

As shown on Figure 1 contributory features of secondary significance are:

- Corrugated iron clad Interwar dairy and milking shed.

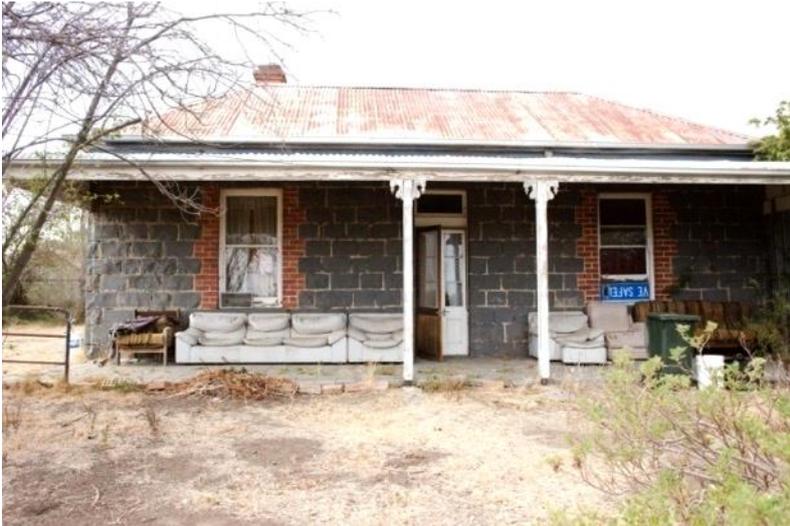
Figure 2. Front or west façade, house, 2019

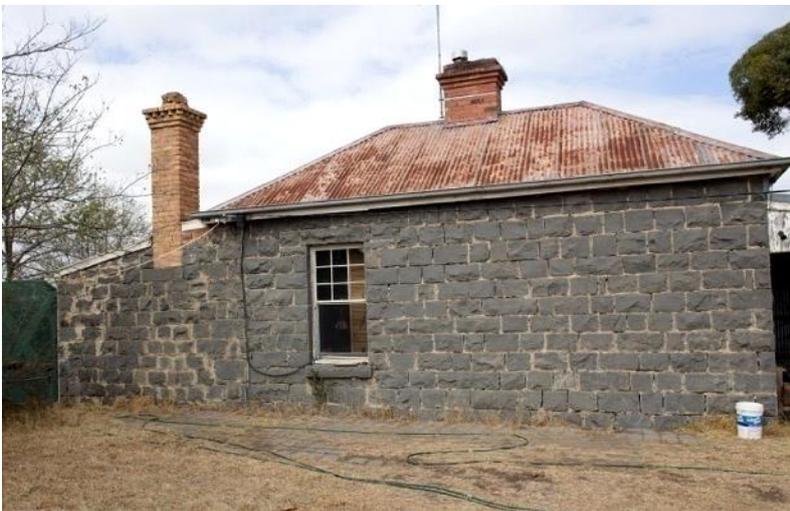
Figure 3. North side wall, house showing stone rubble work at rear of house from earlier phase.

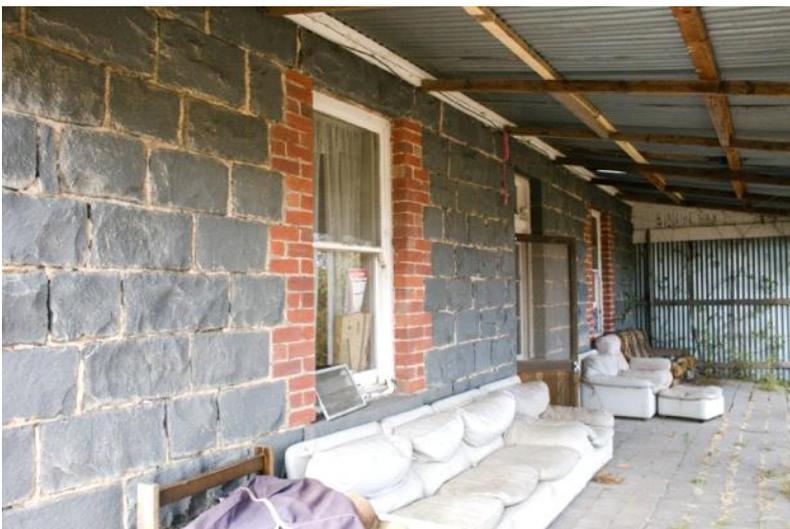
Figure 4. West or front facade, house, 2019

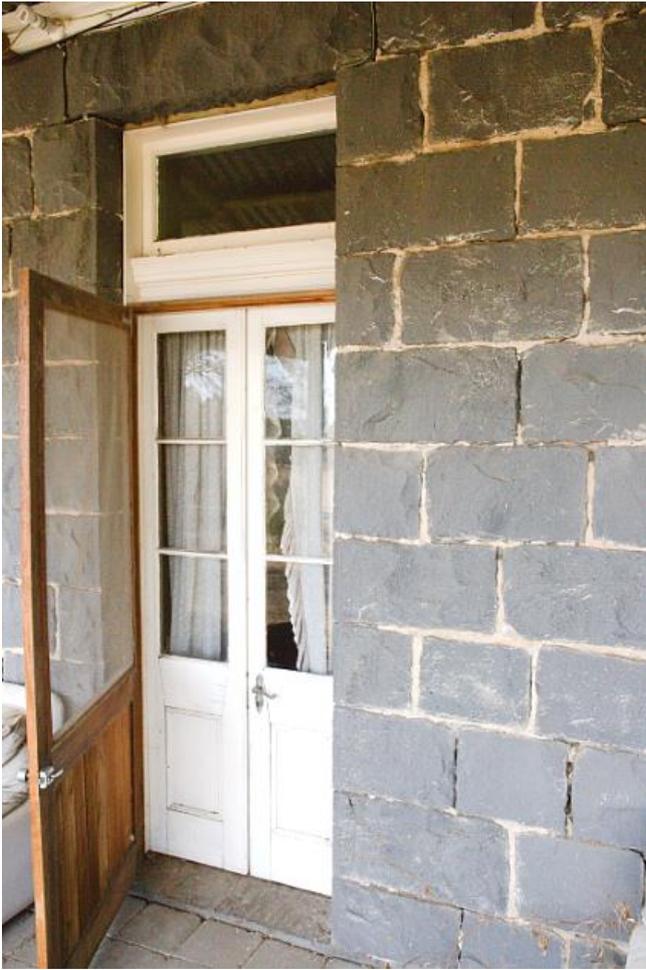
Figure 5. French door pair to west façade, house, 2019

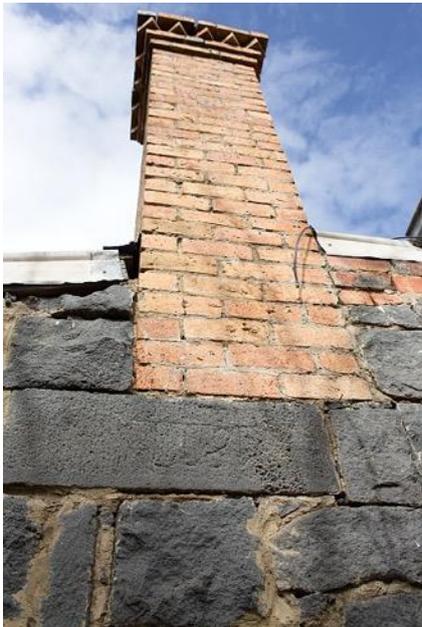
Figure 6. North wall rear wing brick chimney with date stone under (1850s?), 2019

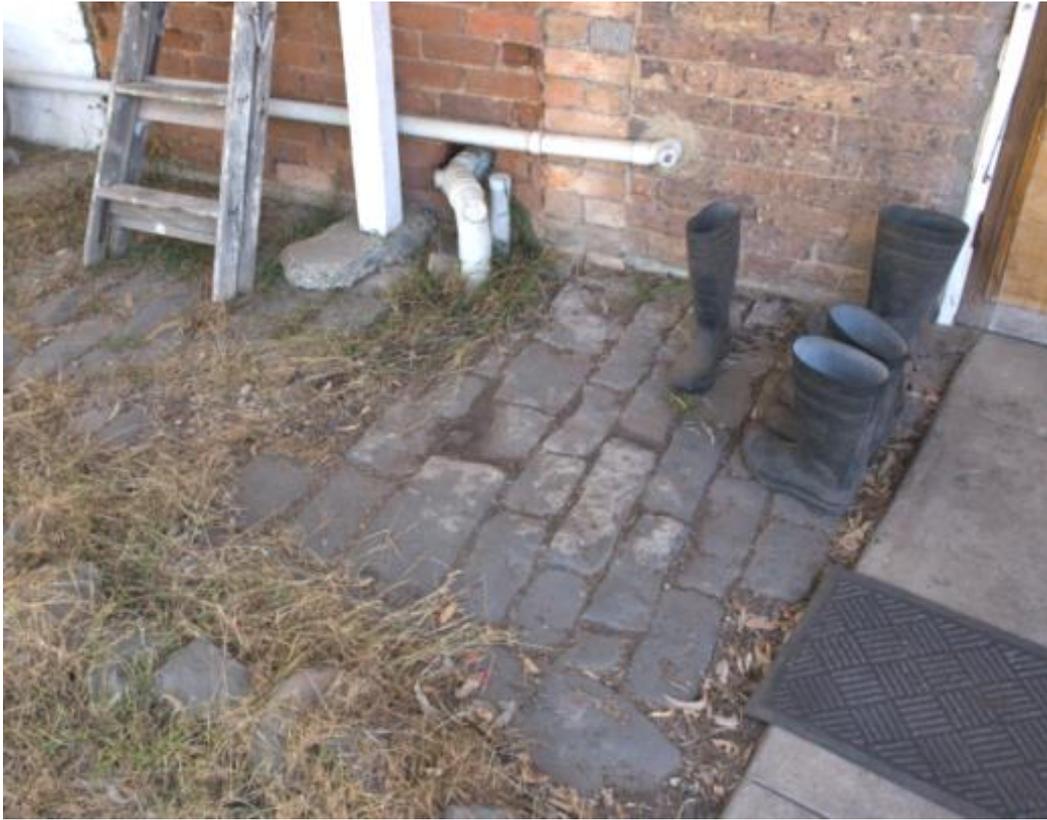
Figure 7. Basalt paving, rear verandah, 2019

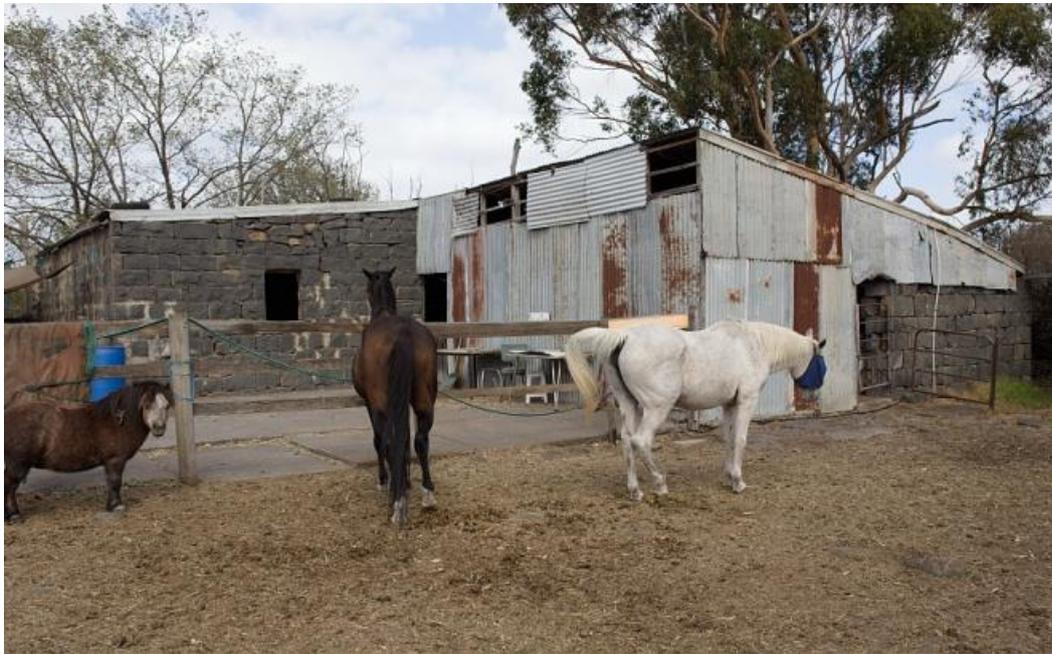
Figure 8. North elevation of stable shed complex, 2019

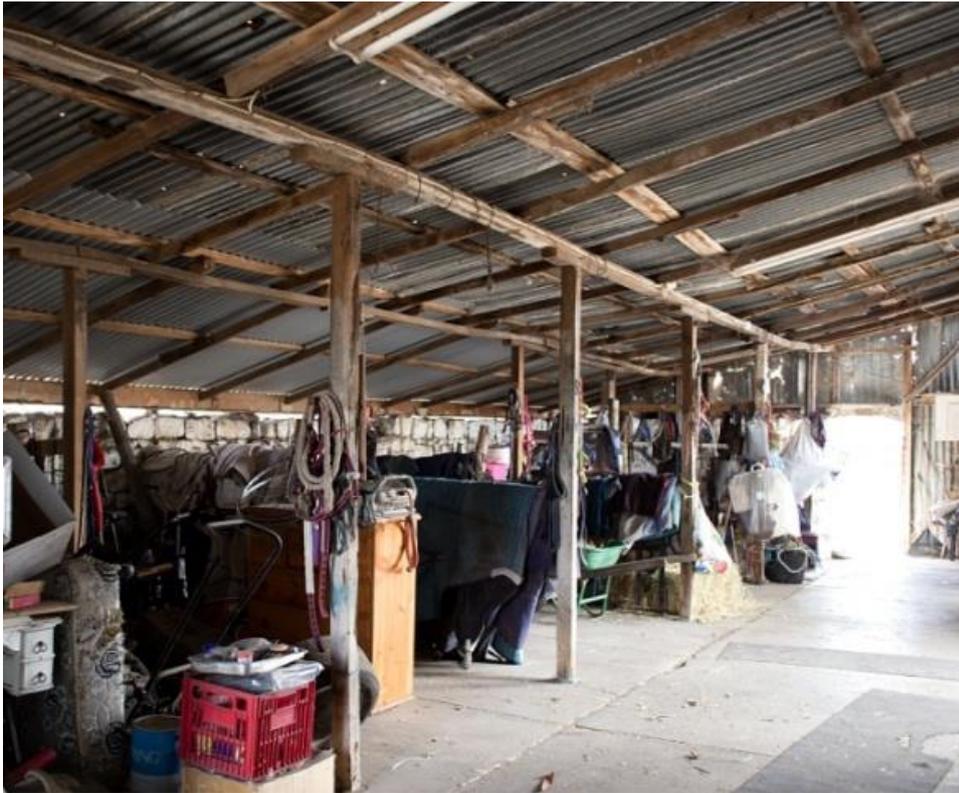
Figure 9. Cow bails, 2019

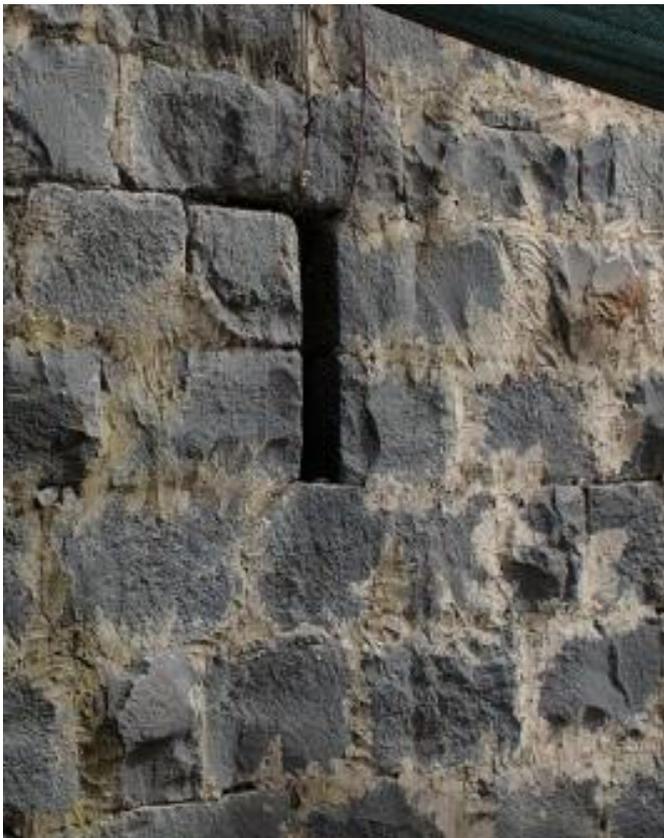
Figure 10. Lancet opening, east wall of stable-shed complex, perhaps for a barn or stable, 2019

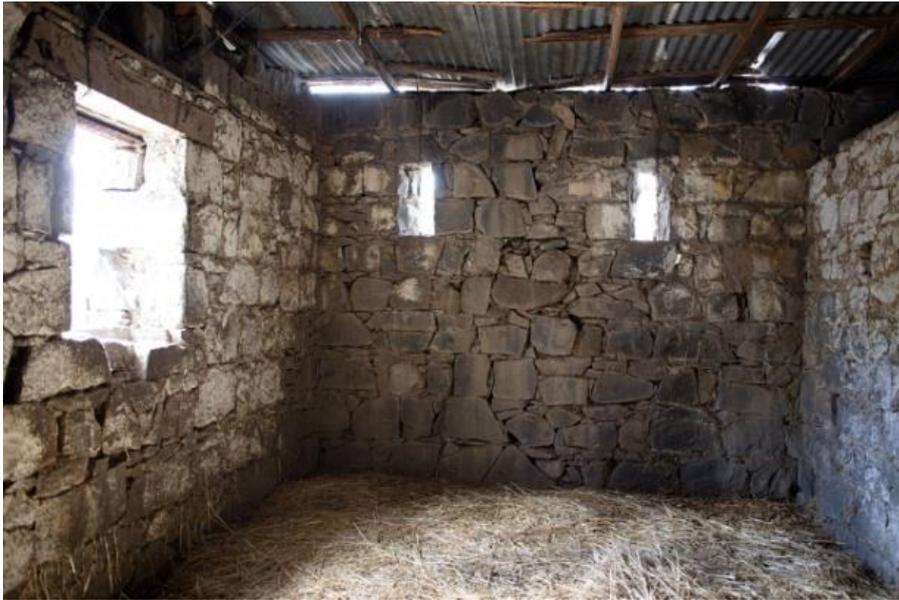
Figure 11. Lancet opening, inside east wall of stable-shed complex, perhaps for a barn or stable adjoining later milking shed, 2019

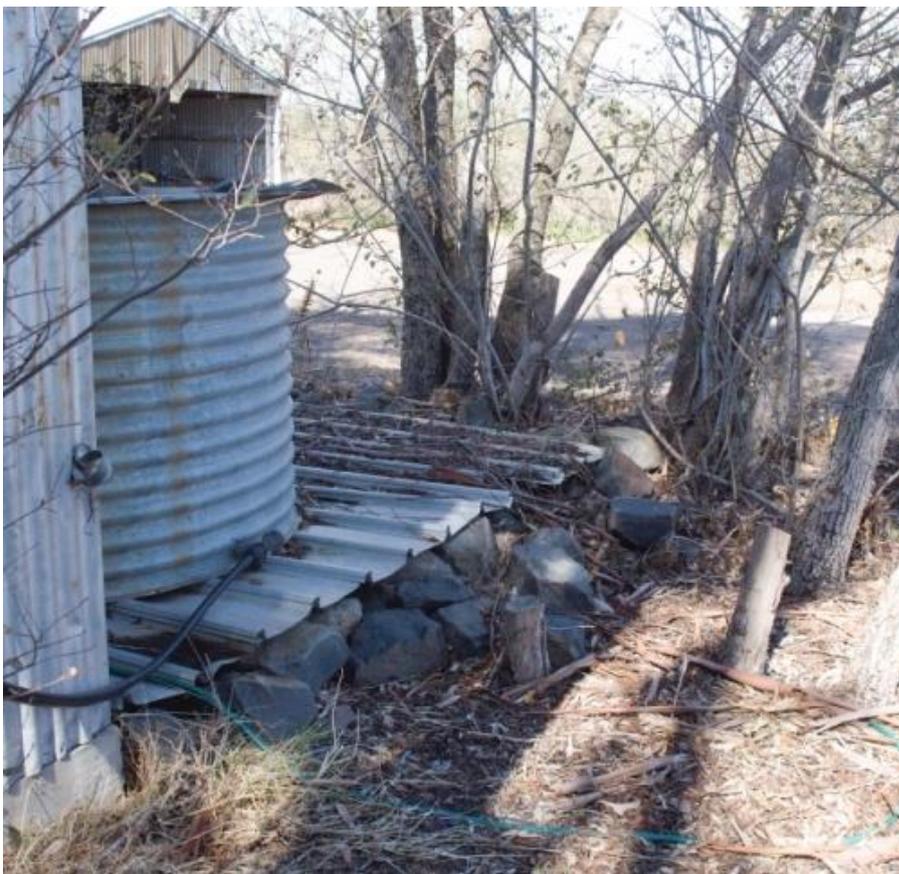
Figure 12. Underground tank, 2019

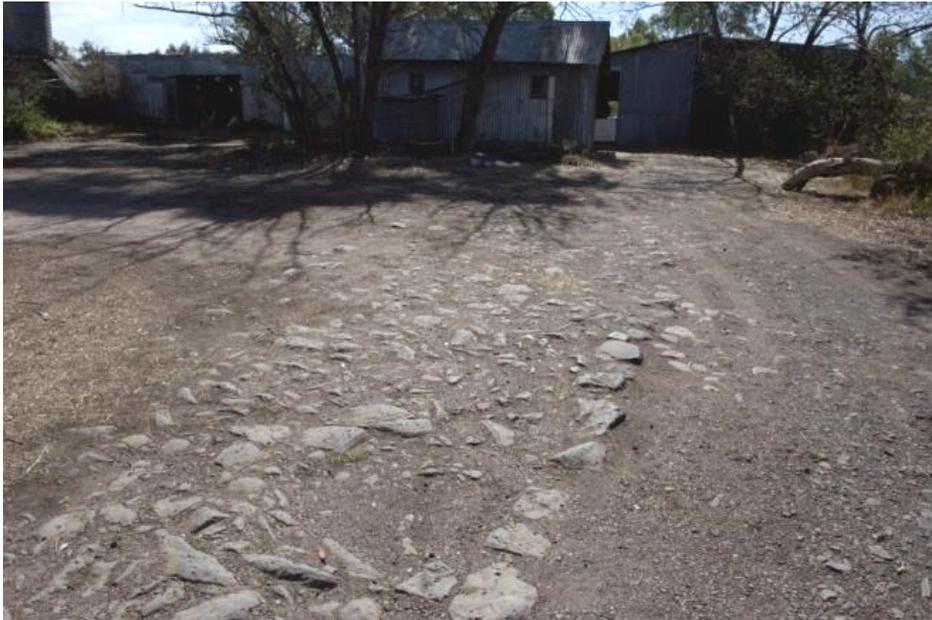
Figure 13. Rubble stone farm yard and track, part, paving east of house, 2019

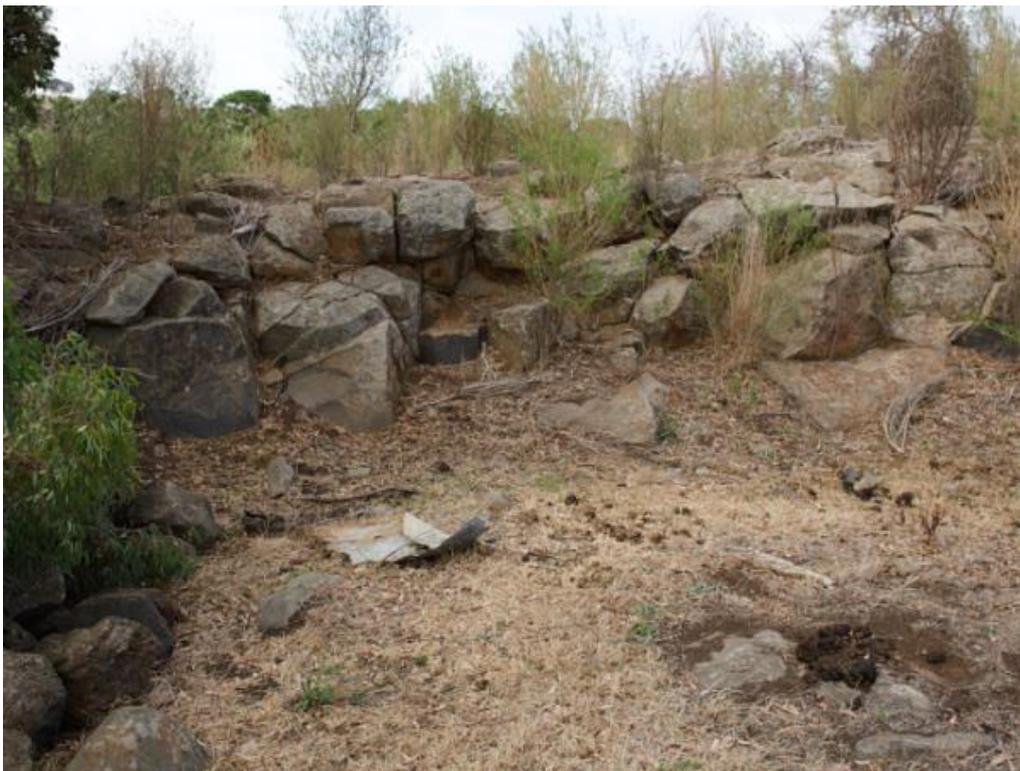
Figure 14. Quarry, south east of farm complex, 2019
